CHAPTER 17

Part 1 of 2

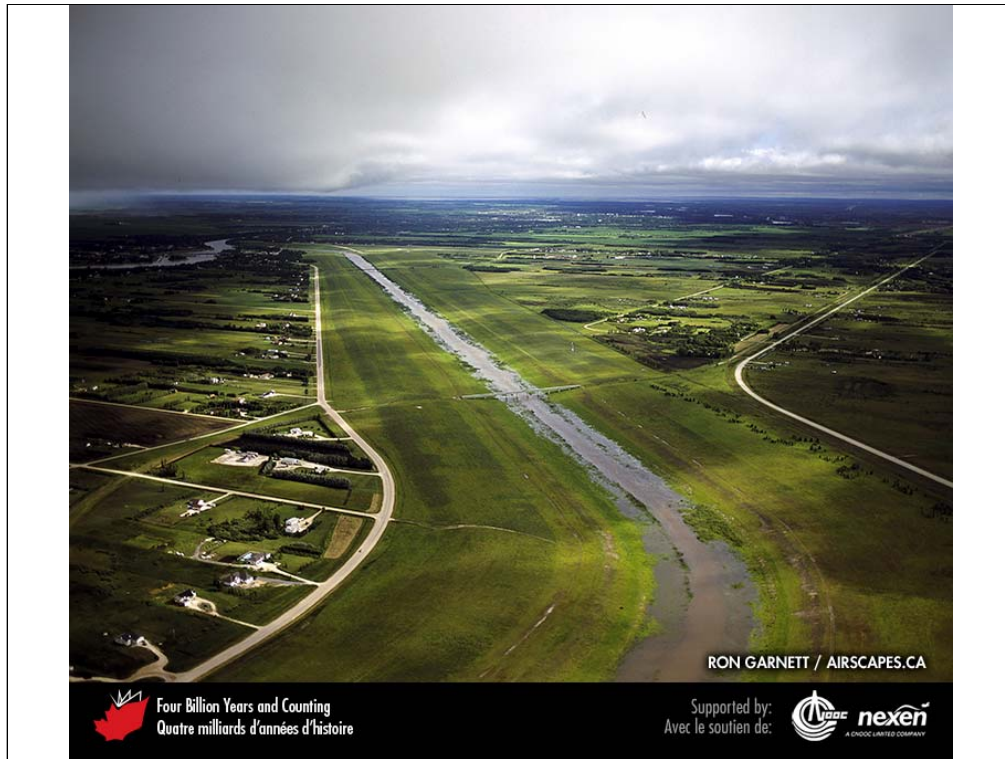
Practically every year at least one part of Canada is affected by serious flooding. The Red River Valley in southern Manitoba is a particularly vulnerable area. During winter, heavy snow tends to accumulate upstream, leading to the possibility of devastating floods downstream during spring melt. The city of Winnipeg is protected from the worst impact of the “Red Sea” floods by the Red River Floodway, which channels peak flows around the city. RON GARNETT / AIRSCAPES.CA.

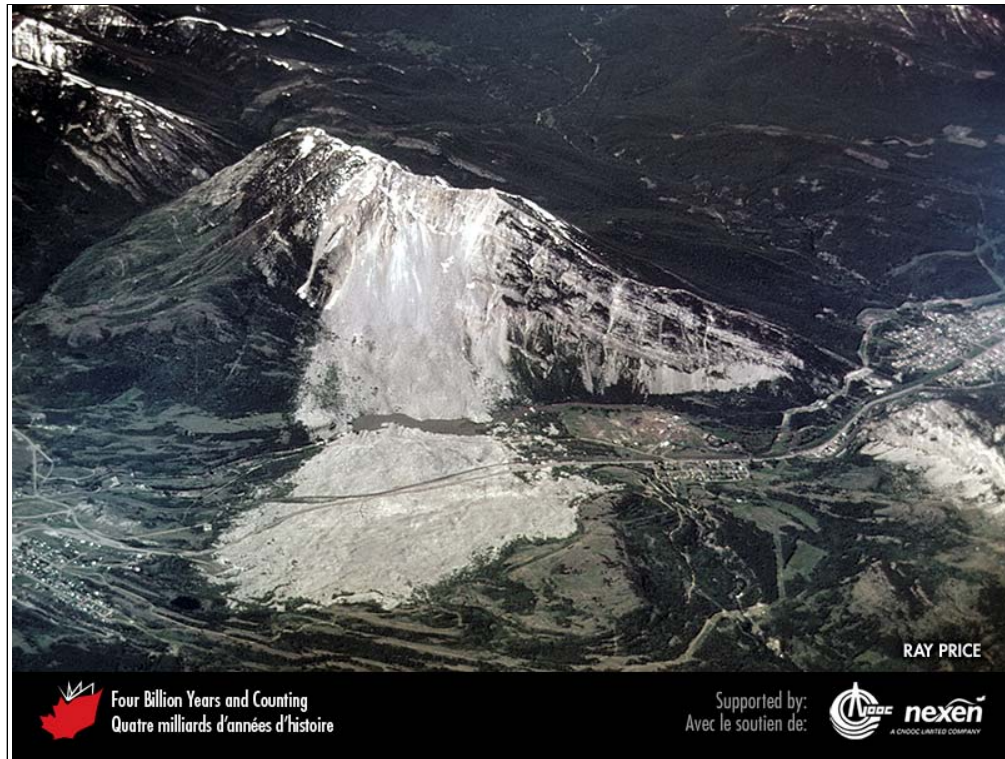
The scar on Turtle Mountain and the debris field of the Frank Slide, southwestern Alberta. The debris lobe is now crossed by a highway and a railway. RAY PRICE.

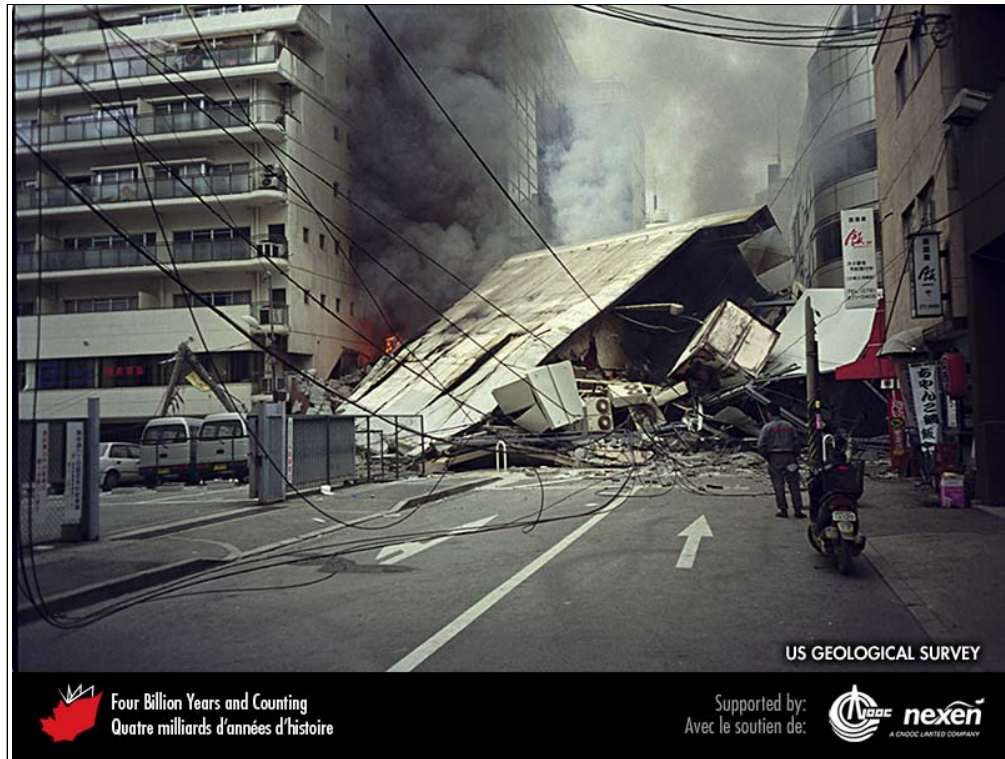
A building that collapsed during the Kobe earthquake in Japan in January 1995. COURTESY OF THE UNITED STATES GEOLOGICAL SURVEY.

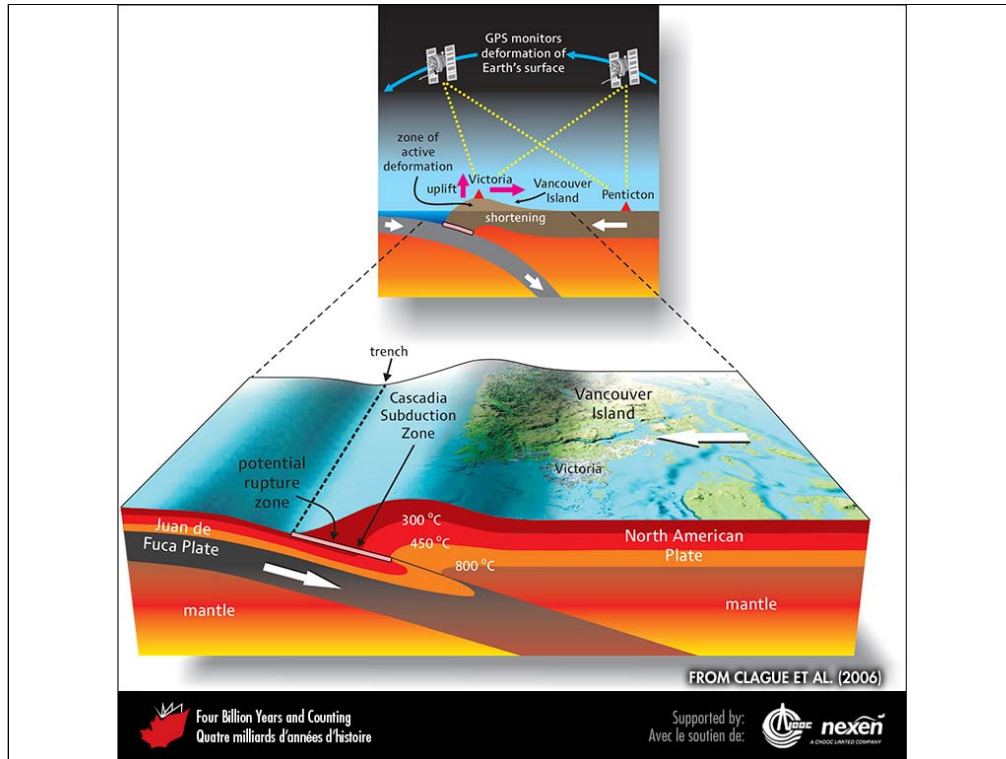
The oceanic Juan de Fuca Plate is presently locked to the North American Plate where the temperature of the crust along the Cascadia Subduction Zone is less than 350°C. This locked region is where the next great Cascadia earthquake will be initiated. The 450°C isotherm delineates the landward limit of potential rupture; at higher temperatures the rocks are too ductile to break. Vancouver Island is being flexed upward due to compression and elastic shortening of the North American Plate above the locked interface. This deformation has been detected from satellite measurements of small changes in the relative position of points on the Earth's surface. Sometime within the next several hundred years the plates will suddenly unlock, triggering a great earthquake. FROM CLAGUE ET AL. (2006), USED WITH PERMISSION OF THE AUTHORS AND TRICOUNI PRESS.

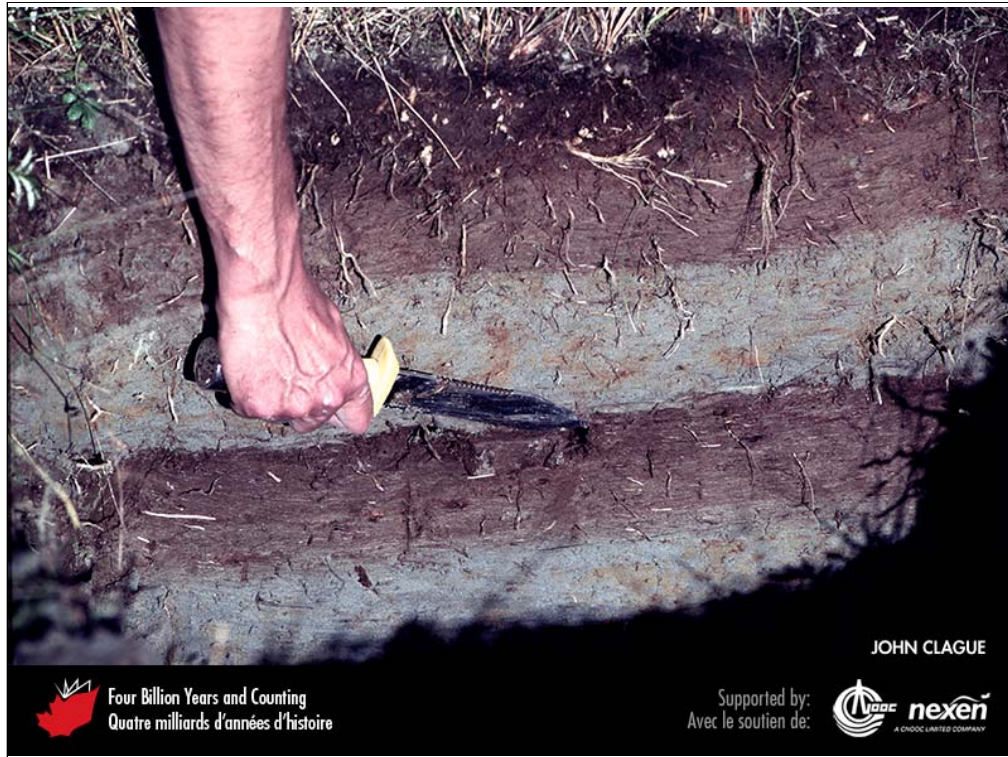
This section dug into a tidal marsh near Tofino, British Columbia, provides evidence for past earthquakes in the region. The tip of the knife is at the top of a buried marsh surface, which is in turn overlain by about 10 centimetres of tsunami-deposited sand. This and other evidence show that the marsh subsided and was inundated by a tsunami during the last great earthquake at the Cascadia Subduction Zone in January 1700. JOHN CLAGUE.

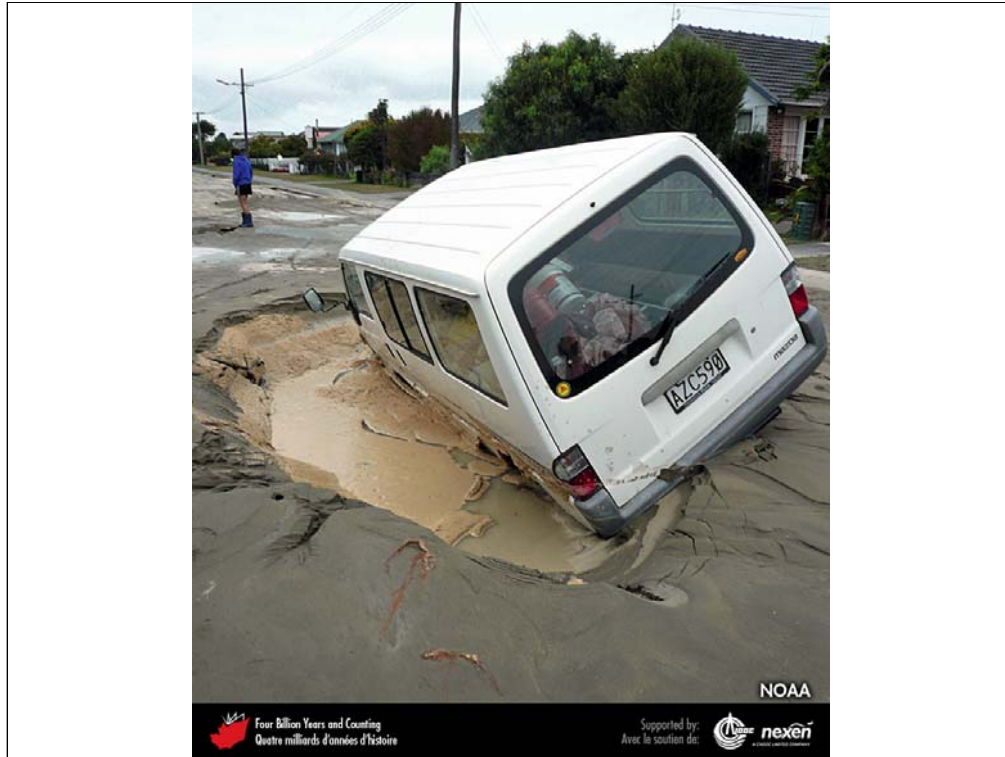
Strong shaking during earthquakes can liquefy loose, water-saturated sediments, as in Christchurch, New Zealand, during the February 2011 earthquake. COURTESY OF NOAA.

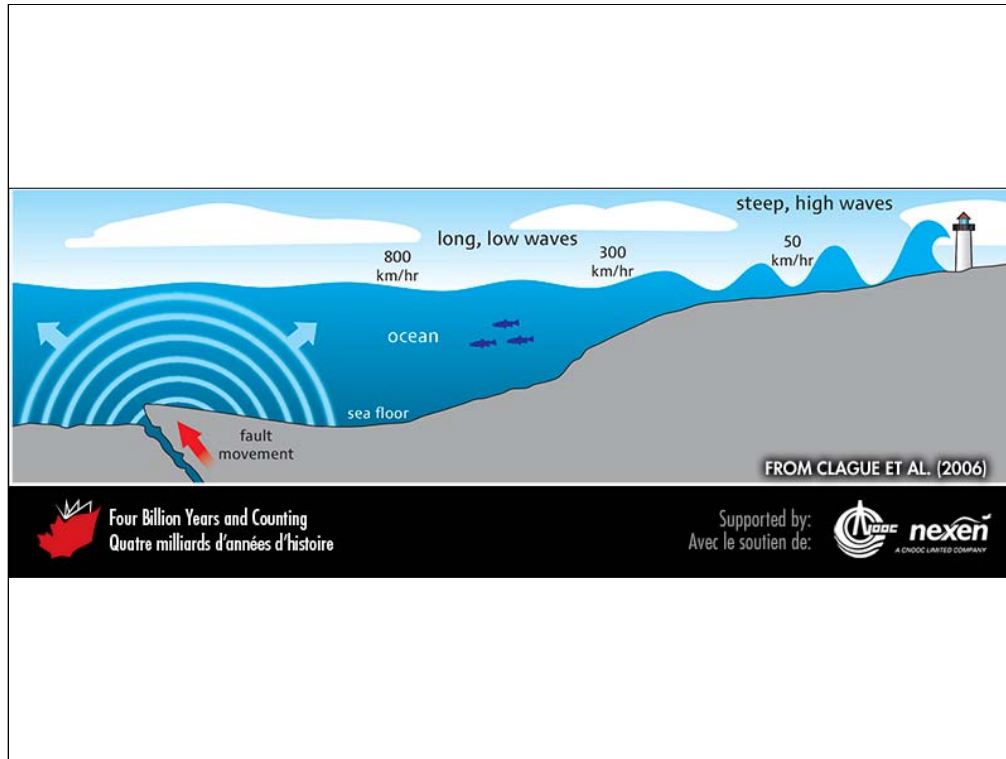
A tsunami can be triggered by rupture of the sea floor along a fault during an earthquake. The sudden upward displacement of the sea floor produces tsunami, which often have a deadly impact when they reach shore. The values in kilometres-per-hour show how much a tsunami loses speed as it moves shoreward. FROM CLAGUE ET AL. (2006), USED WITH PERMISSION OF THE AUTHORS AND TRICOUNI PRESS.

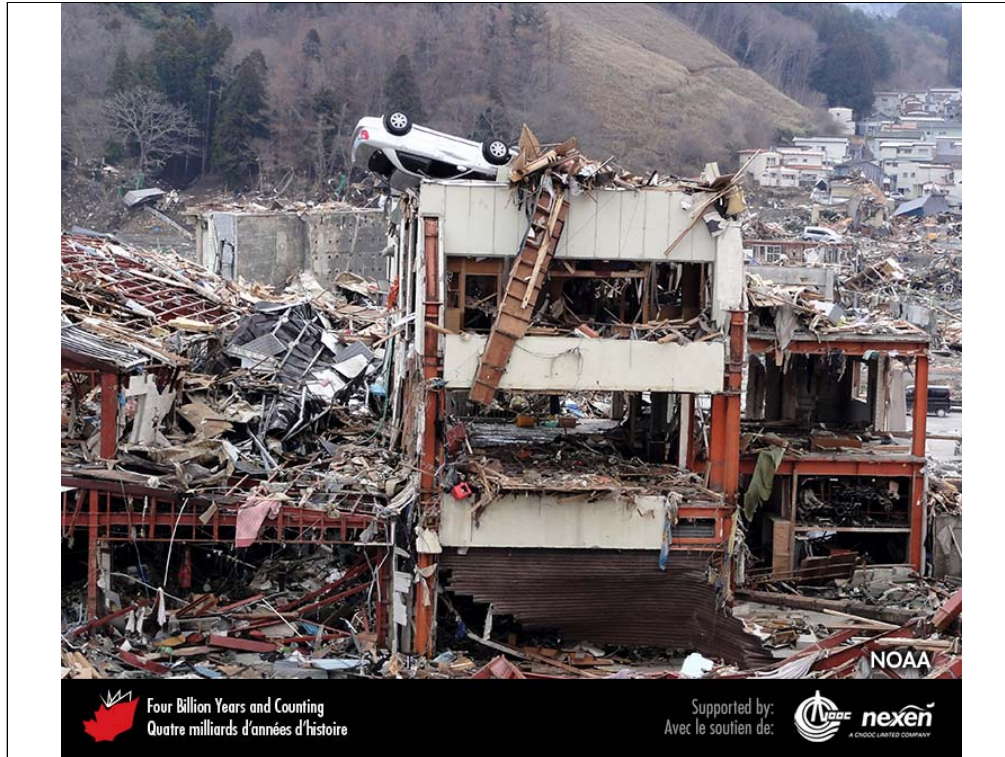
Destruction wrought by the 2010 earthquake and tsunami on the Oshika Peninsula, northeastern Japan. COURTESY OF NOAA.

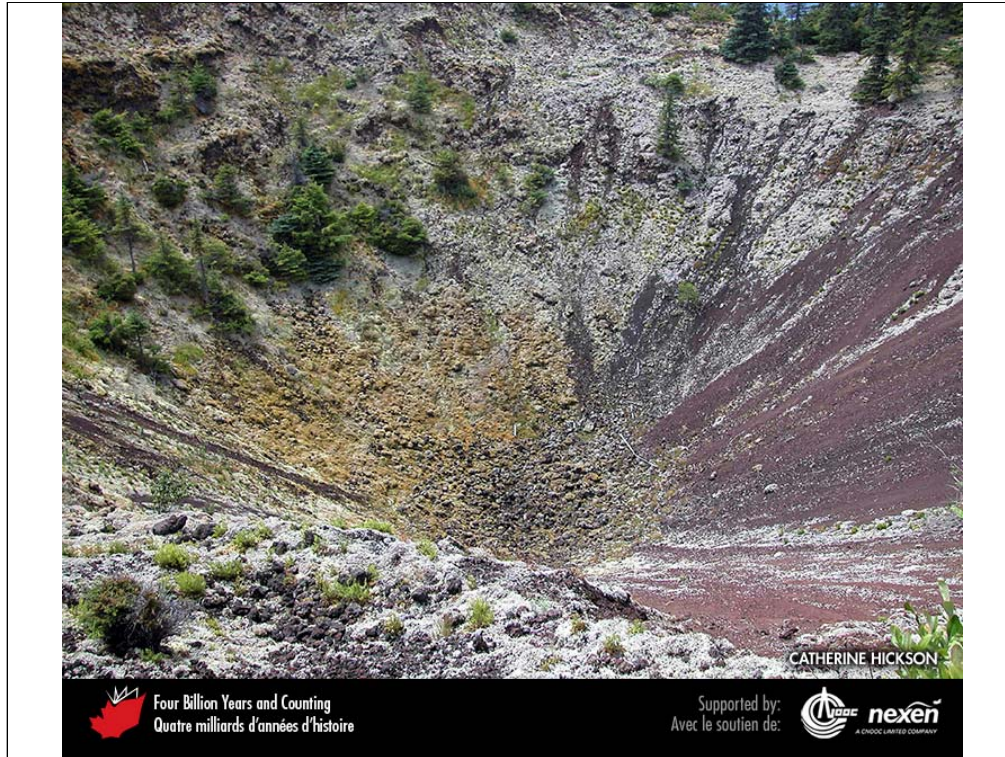
The crater in the Tseax Cone, which erupted around 1775, producing an explosive pyrotechnics show, is vividly remembered in Nisga'a oral history. The Tseax Cone and its associated lavas are part of the Stikine Volcanic Belt in northern British Columbia. CATHERINE HICKSON.

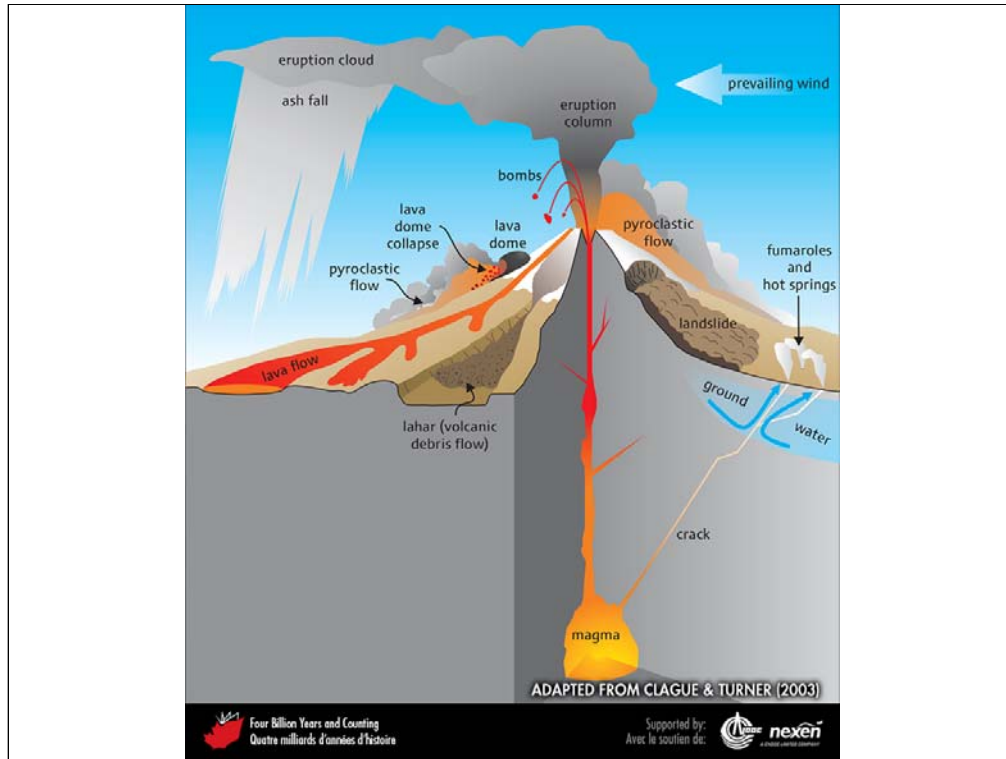
Types of hazards associated with explosive eruptions of stratovolcanoes such as Mount Garibaldi and Mount Meager. Fumaroles are surface openings that emit steam and other gases such as sulphur dioxide and carbon dioxide. ADAPTED FROM CLAGUE AND TURNER (2003); USED WITH PERMISSION OF THE AUTHORS AND TRICOUNI PRESS.

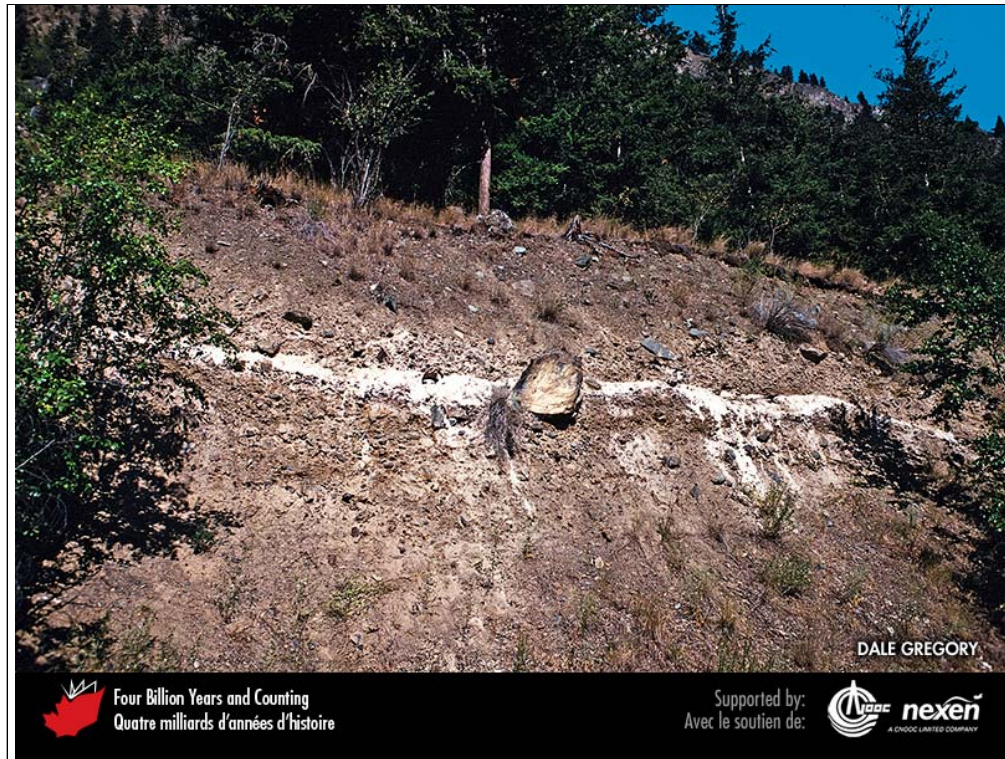
Exposed in a road cut along Highway 3 near Keremeos, British Columbia, the white layer is volcanic ash from the eruption of Mount Mazama in Oregon, 7,700 years ago. DALE GREGORY.

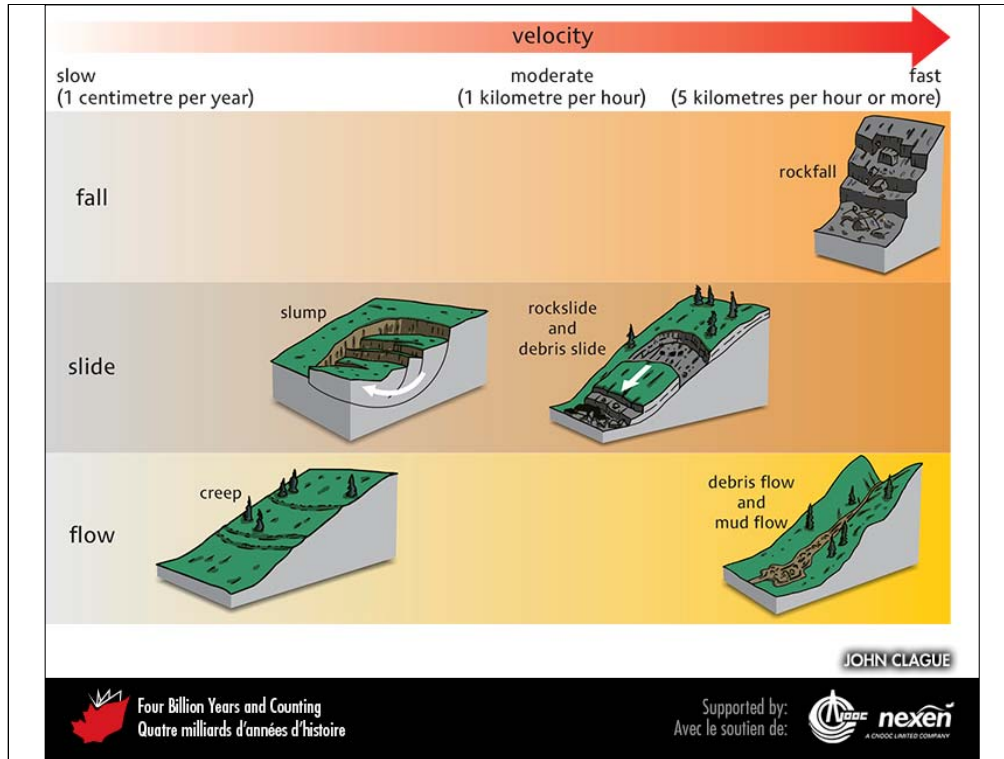
Types of landslides. Landslides are classified according to type of movement (fall, slide, or flow); type of material that fails (i.e., rock or unconsolidated sediment); amount of water or air involved in the movement; and velocity.

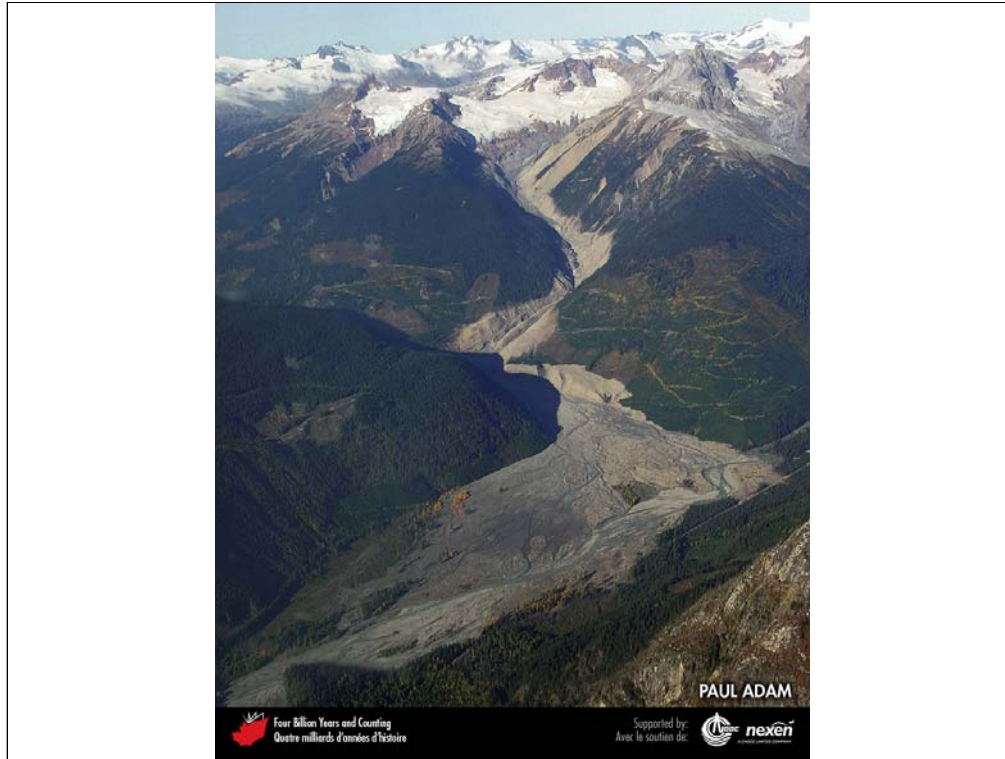
Large landslide resulting from the collapse of the south flank of Mount Meager, British Columbia, in August 2010. PAUL ADAM.

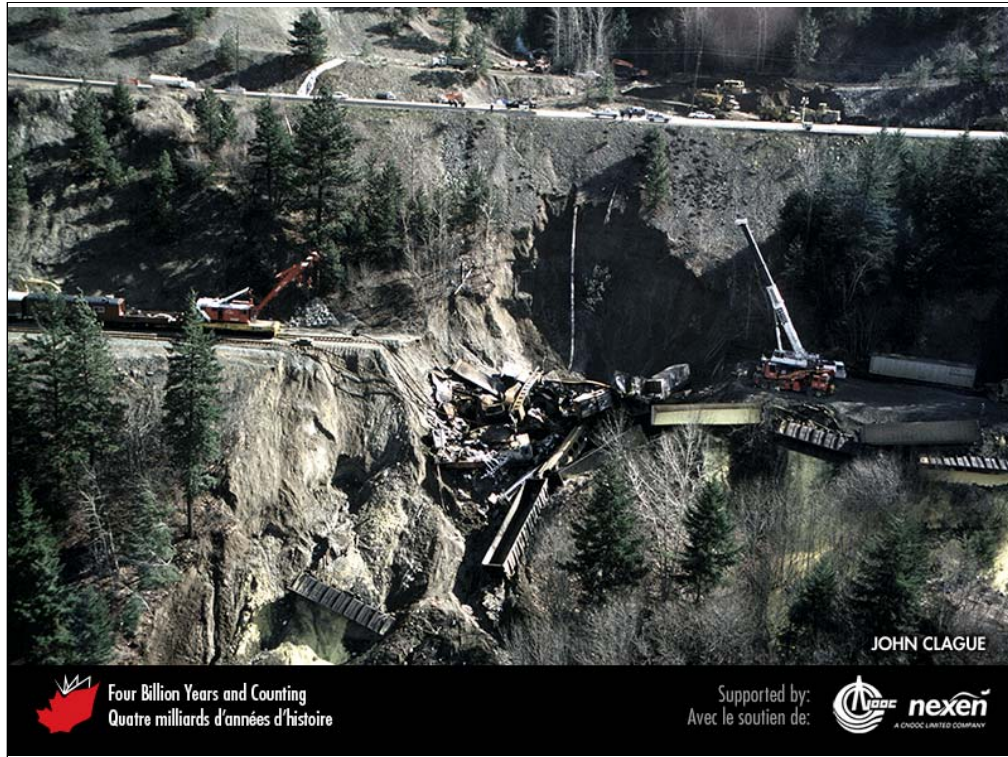
Landslide south of Lytton, British Columbia, in March 1997. The landslide severed the Canadian National Railway line, causing a freight train to derail with the loss of two lives. JOHN CLAGUE.

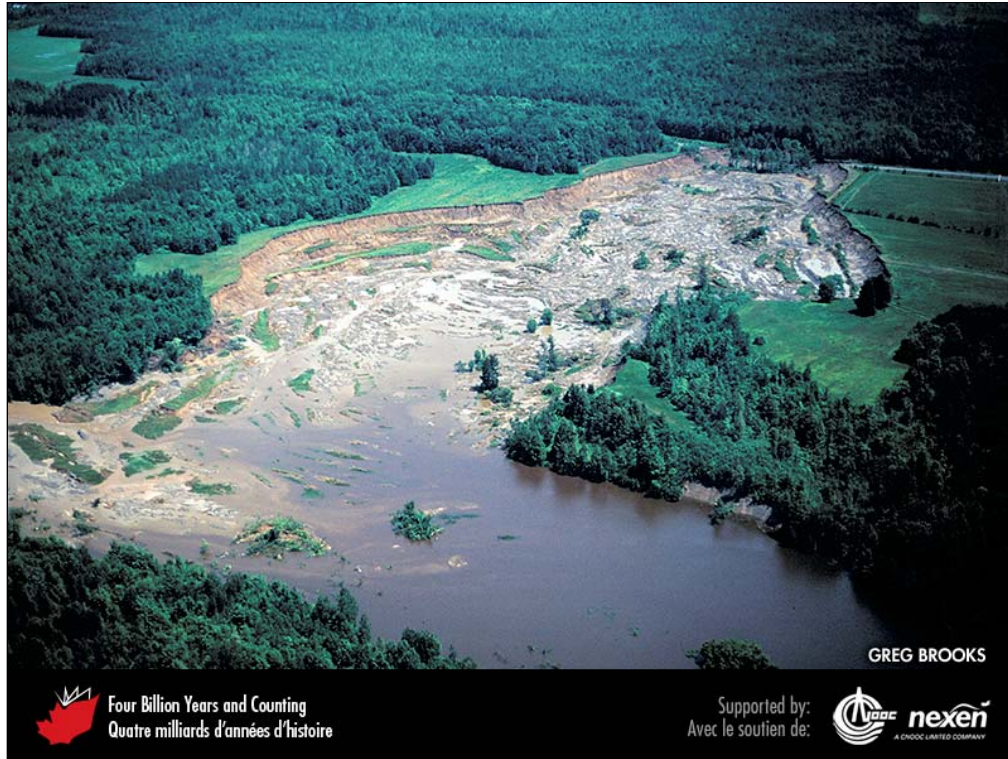
The 1993 Lemieux Landslide in the valley of the South Nation River, Ontario. Such landslides resulting from the sudden liquefaction of Leda Clay, a deposit of the Champlain Sea. GREG BROOKS, REPRODUCED WITH THE PERMISSION OF NATURAL RESOURCES CANADA 2013, COURTESY OF THE GEOLOGICAL SURVEY OF CANADA.

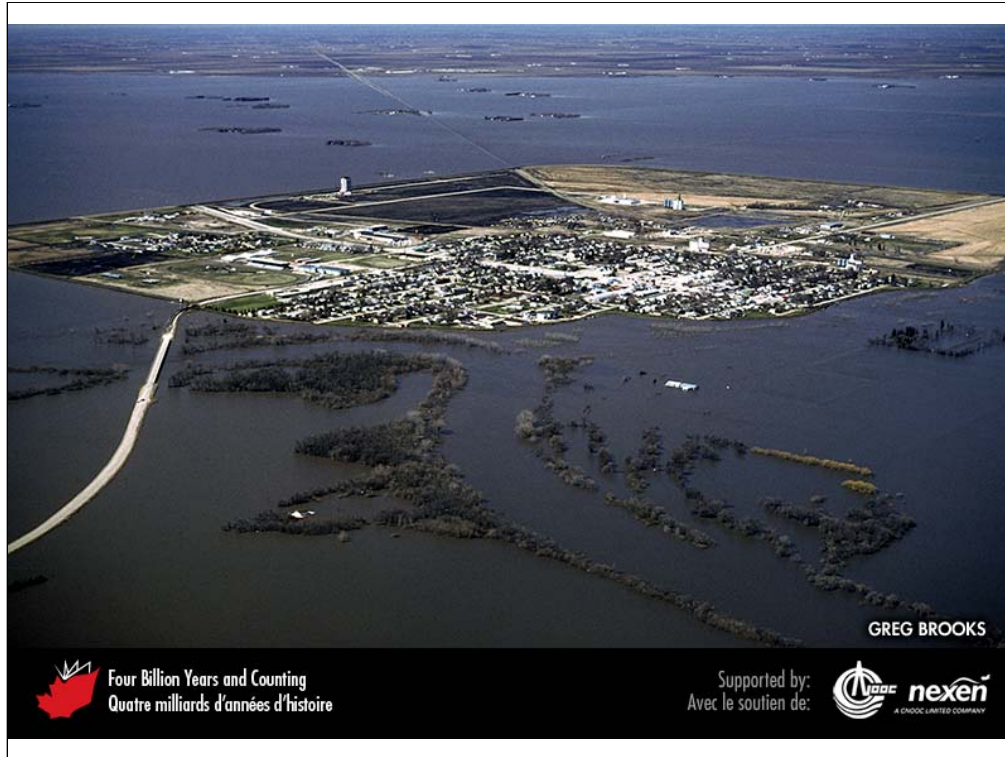
The town of Morris, Manitoba, surrounded by floodwaters during the 1997 Red River flood. Although it resembles an island, the ground surface in Morris is lower than the level of the water; a ring dyke around the town prevents it from being inundated. GREG BROOKS.

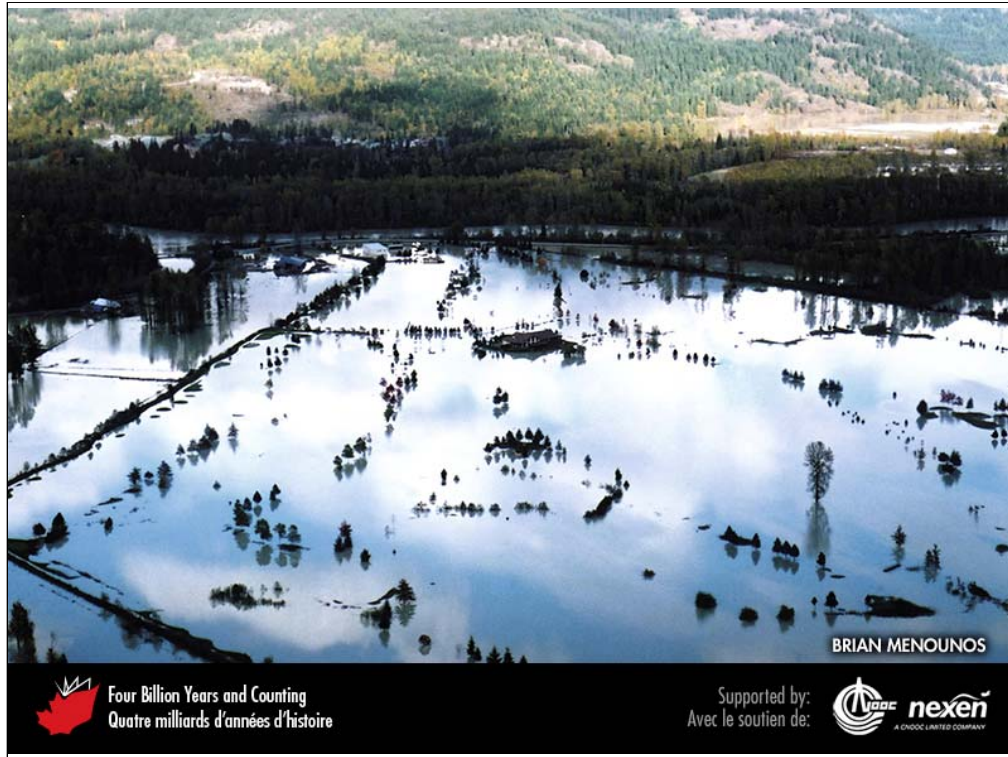
Flooding in the Lillooet River valley at Pemberton, British Columbia, in October 2003.
BRIAN MENOUNOS.

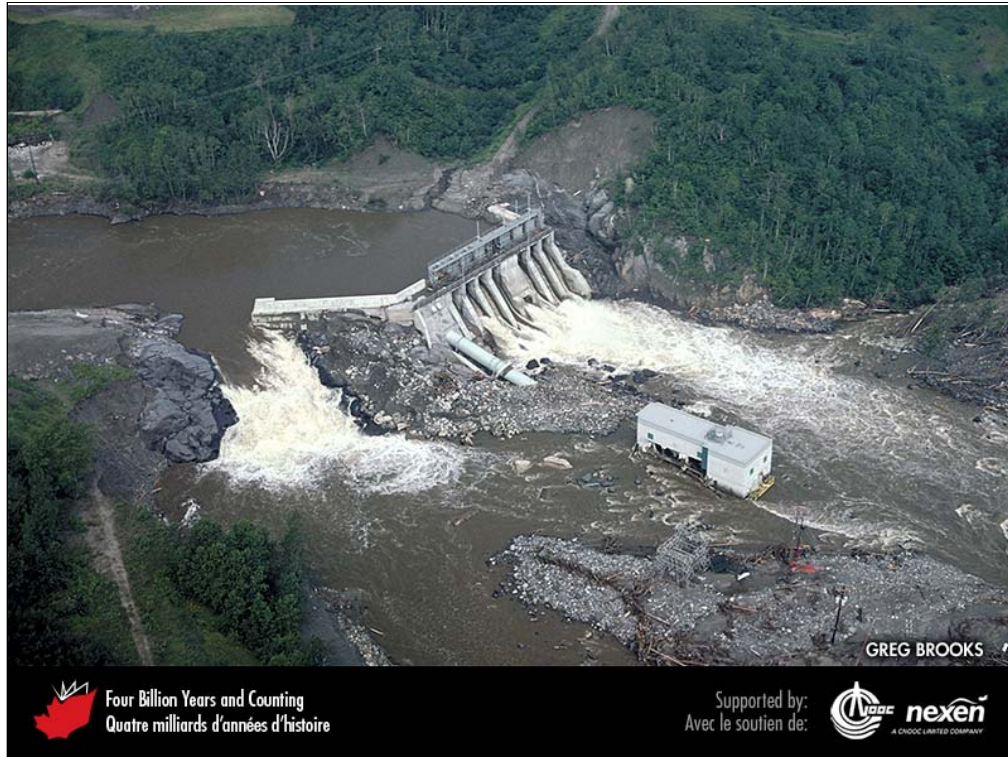
Damage caused by the devastating Saguenay flood in Quebec in July 1996. Waters overflowing the Jonquière Dam on Rivière aux Sables produced a breach about 20 metres wide within the concrete wing of the dam, thereby lowering the reservoir by several metres. Flood waters also severely damaged the powerhouse immediately downstream. GREG BROOKS.
